# modern materials

# Shelter from the Storm

S P F a n d t h e  
h u r r i c a n e s o f F l o r i d a

By Mason Knowles and  
Roger Morrison, PE, RRC

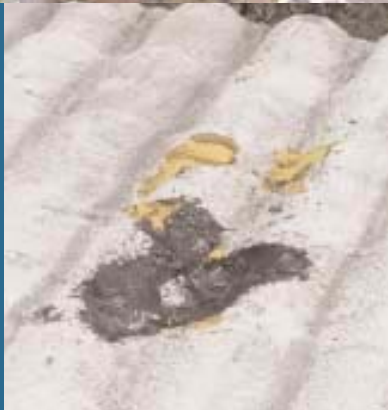
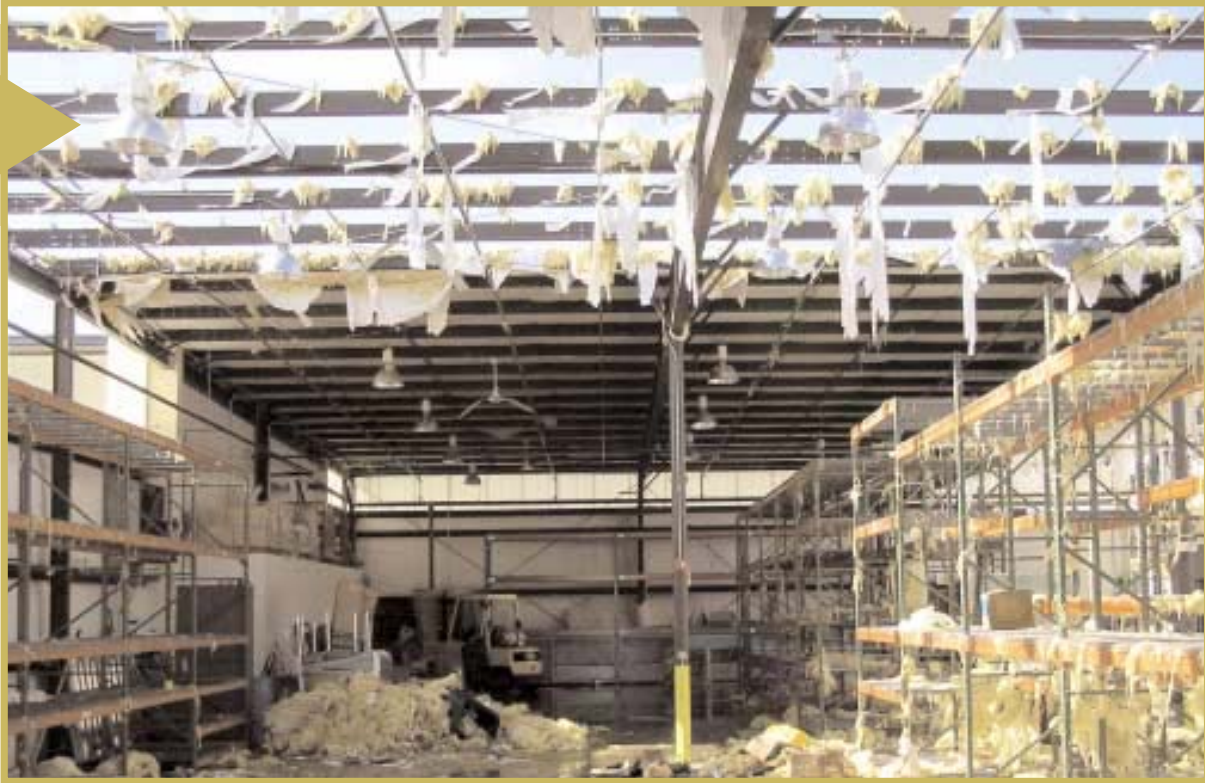
In the summer of 2004, four hurricanes ripped through the state of Florida. The high winds and resulting debris 'missiles' resulted in rampant damage, although many spray polyurethane foam (SPF) systems remained largely unscathed.
